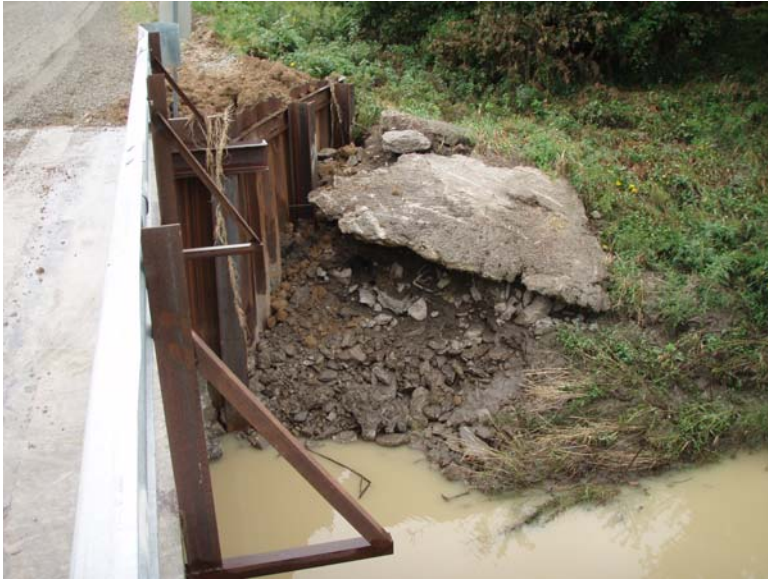
EROSION AT SOUTHWEST CORNER, LOSS OF RIPRAP AND FILL

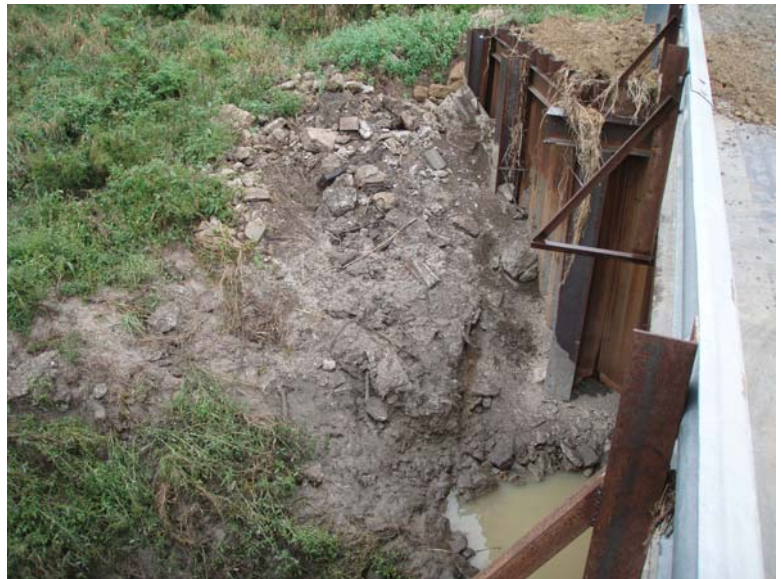
EROSION AT NORTHWEST CORNER

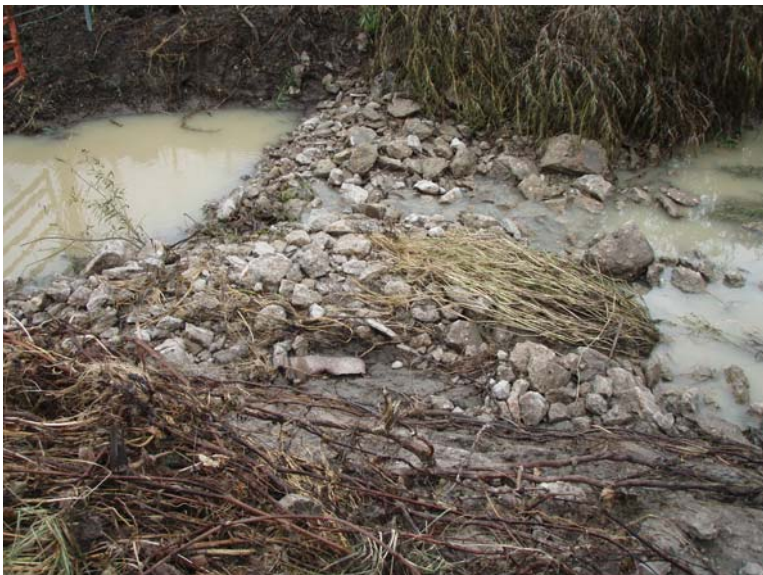
POSSIBLE WIER JUST DOWNSTREAM, DAMAGED
