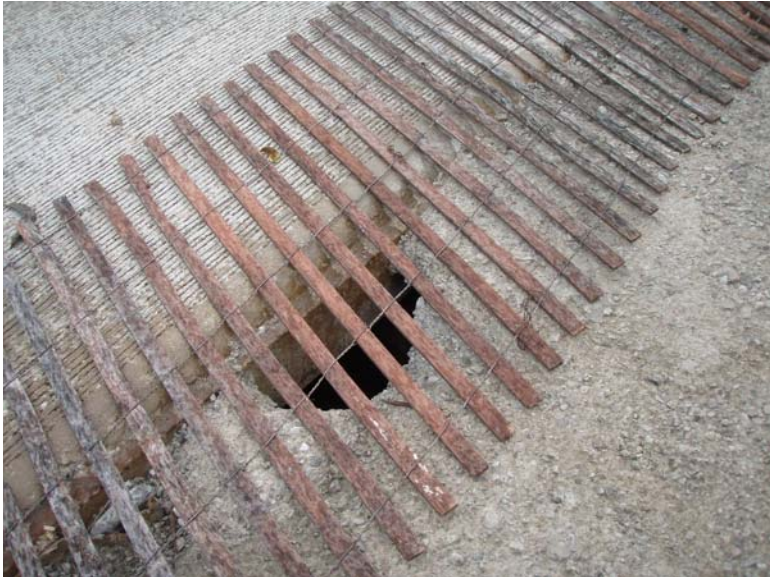
**EROSION BEHIND SOUTH ABUTMENT**

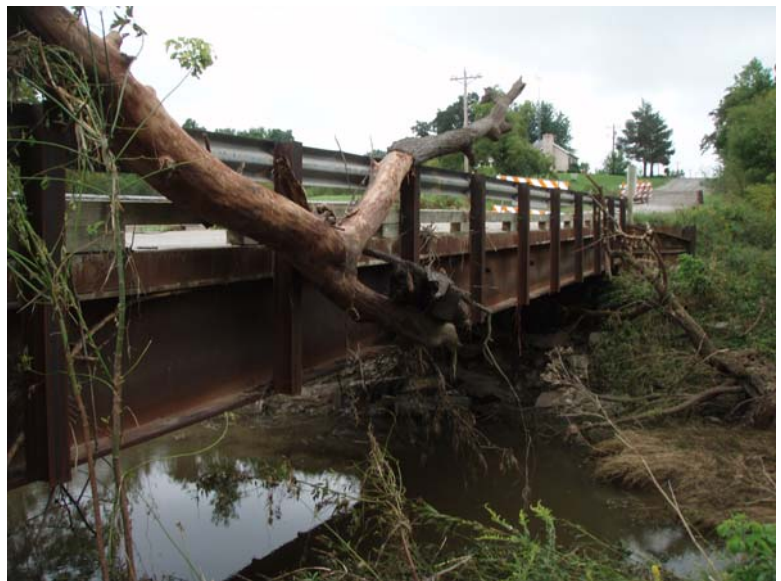
**DRIFT ON RAIL,  
LOOKING SOUTHEAST**

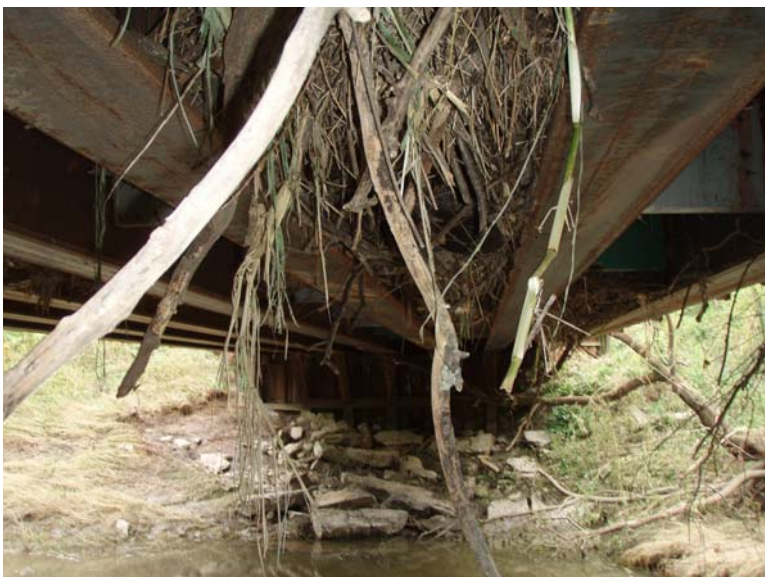
**DRIFT IN SUPERSTRUCTURE,  
LOOKING SOUTH**
