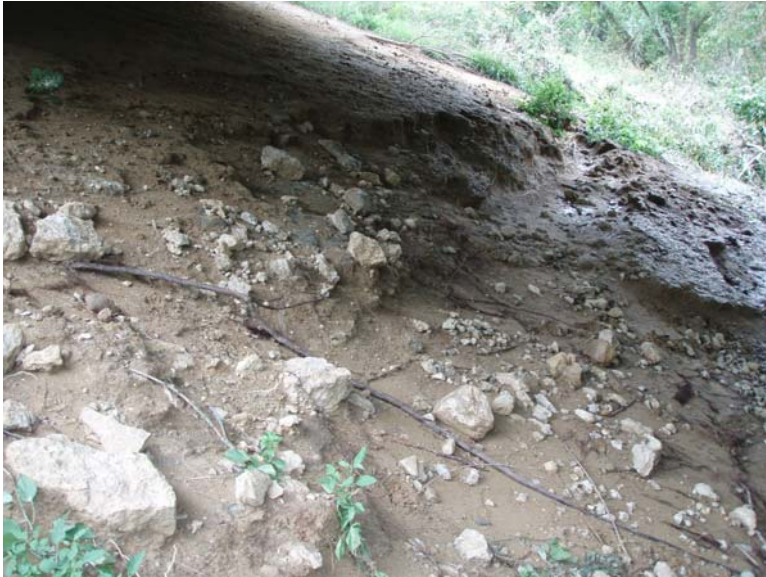
**EROSION OF SOUTH BERM,
LOOKING WEST,
WATER TO 2' ABOVE LOW
SUPERSTRUCTURE**

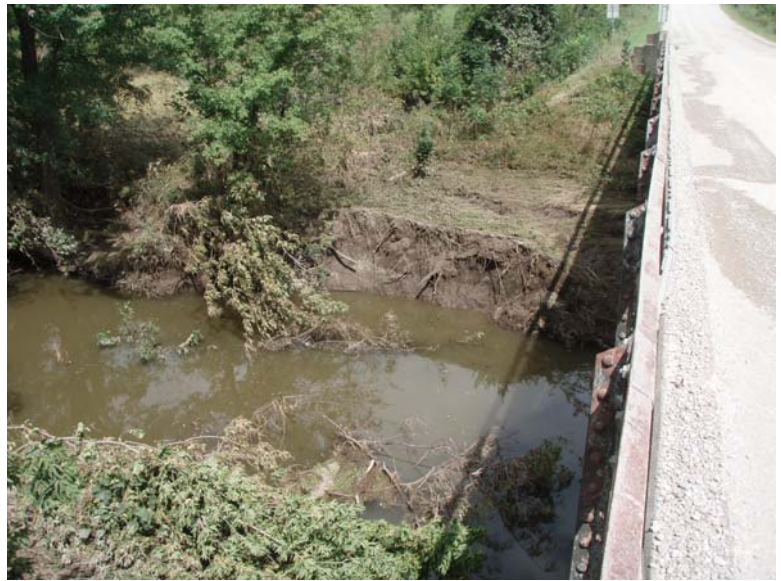
**NORTHWEST BANK EROSION,
LOOKING NORTH**

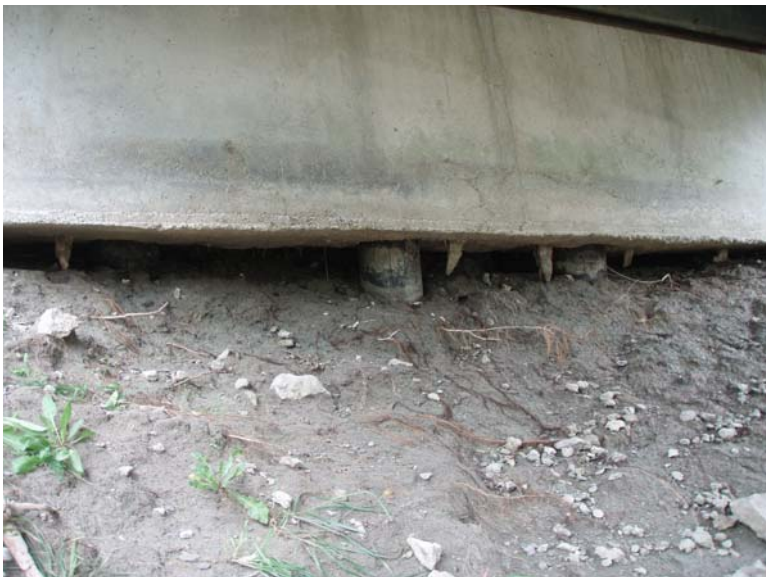
**UNDERMINED NORTH ABUTMENT FOOTING,
LOOKING NORTH**
