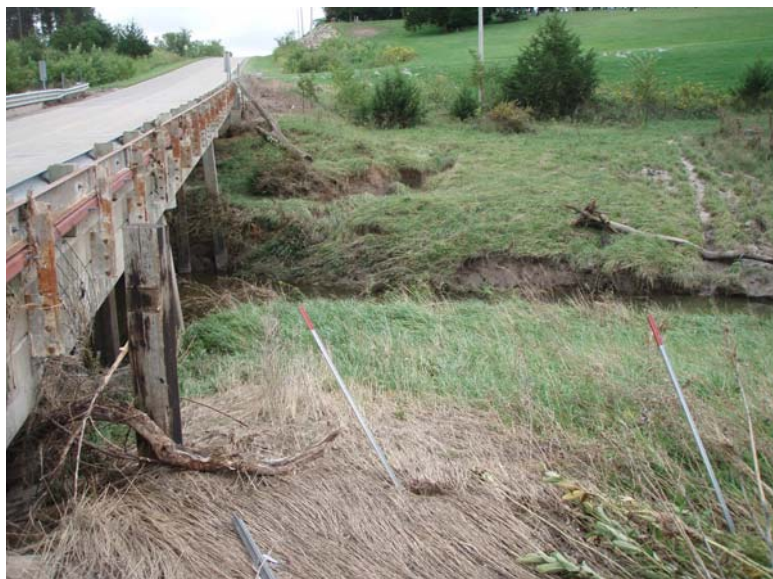
DRIFT ON UPSTREAM SIDE OF BRIDGE

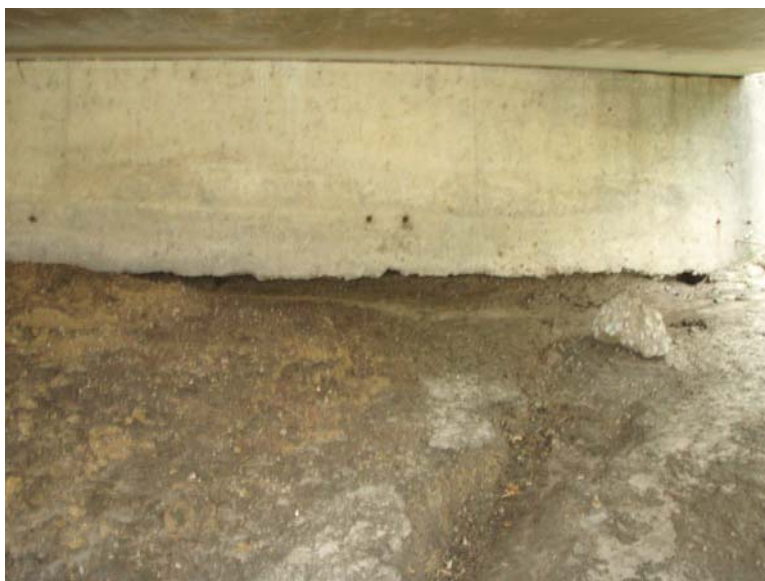
**UNDERMINED NORTH ABUTMENT
FOOTING,
LOOKING NORTH**

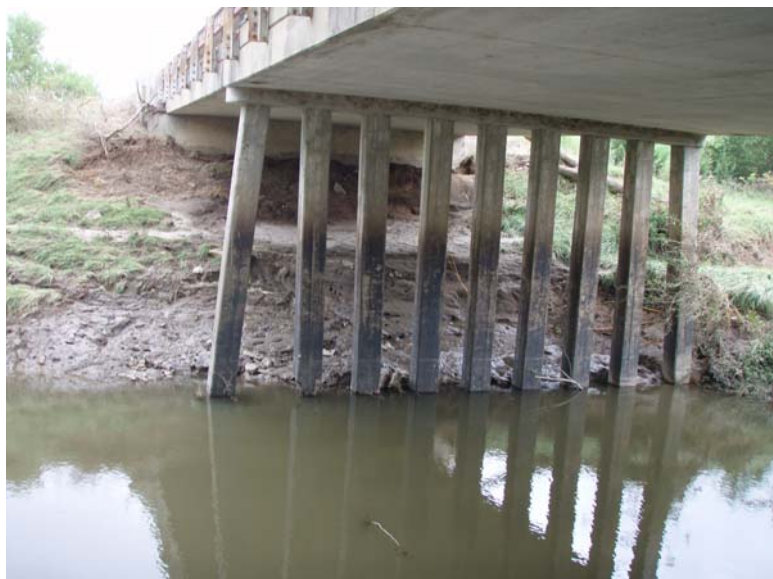
DETERIORATION OF PIER ENCASEMENTS
