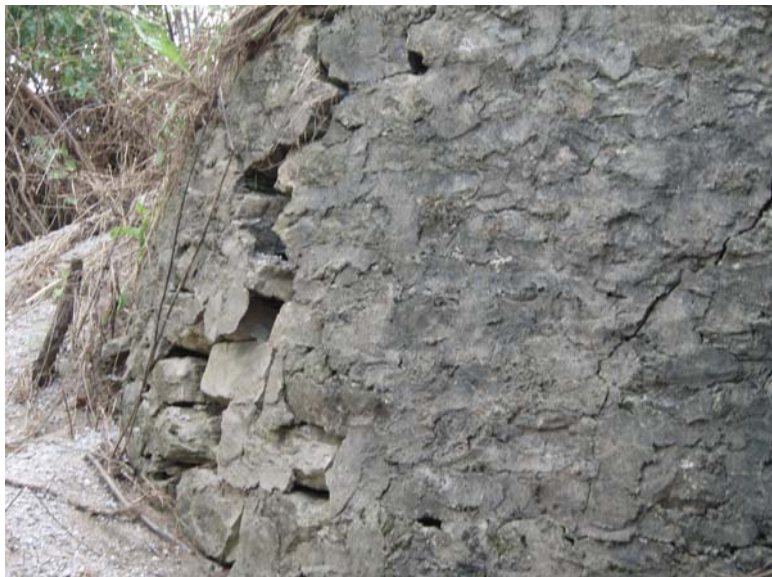
**CRACKED SOUTHEAST WING,
LOOKING SOUTH**

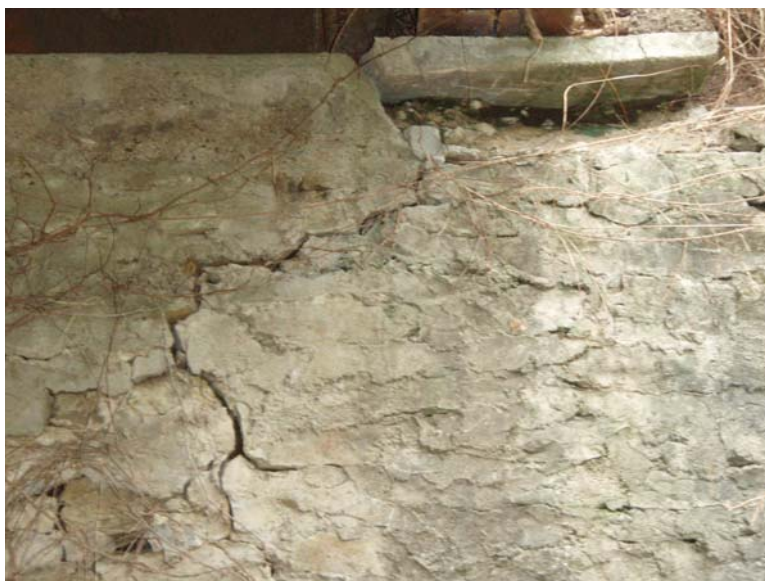
**CRACKED BACKWALL AND
DETERIORATED SOUTHWEST
TRUSS BEARING,
LOOKING SOUTH**

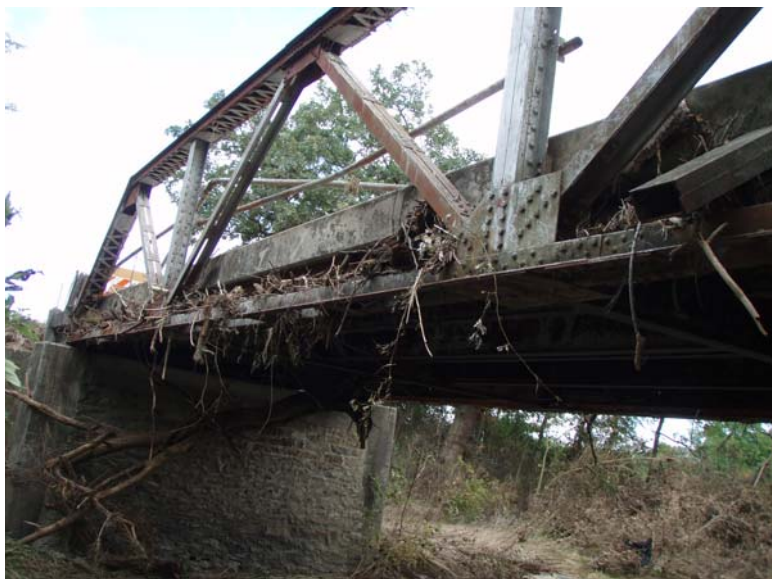
**DRIFT IN SUPERSTRUCTURE,
LOOKING NORTHEAST**
