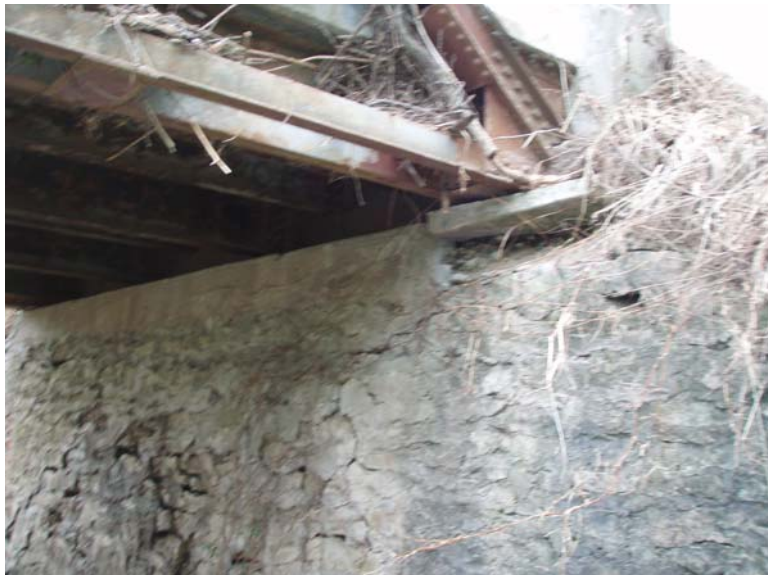
**VERY POOR AND DETERIORATED
SOUTHWEST TRUSS BEARING,
LOOKING SOUTHEAST**

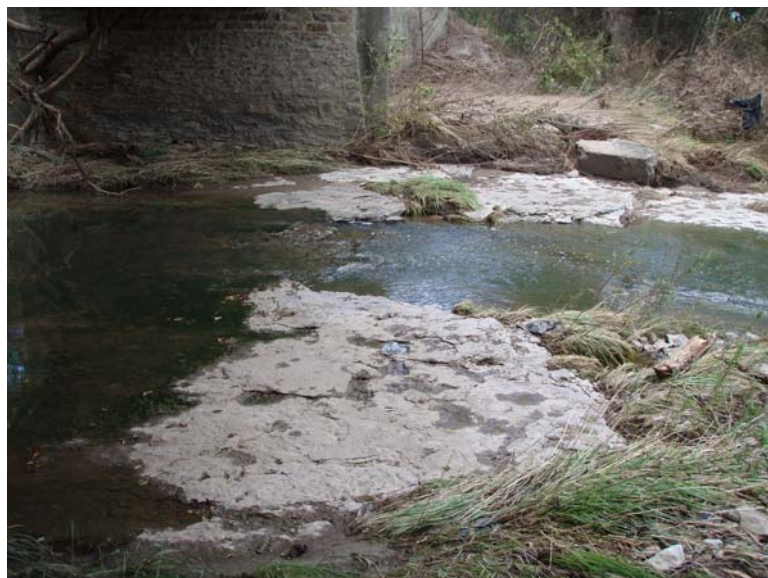
**ROCK STREAM BOTTOM,
LOOKING NORTH**
