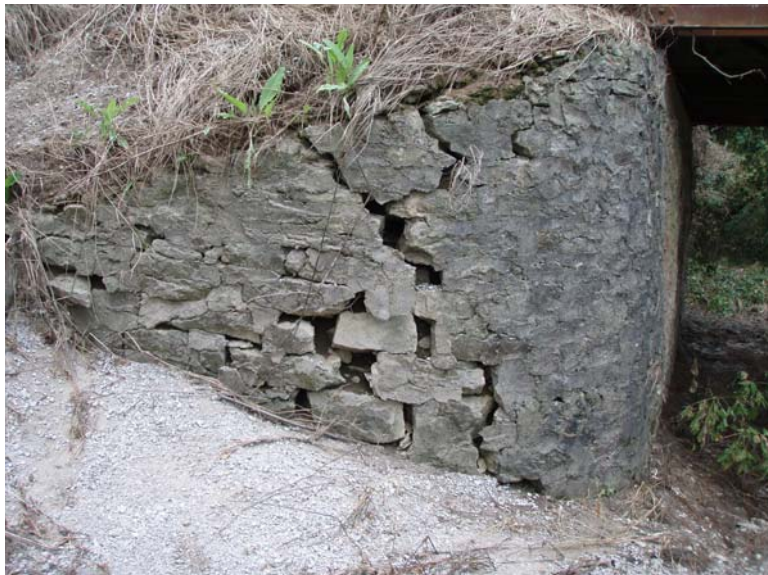
**CRUMBLING AND BROKEN SOUTH
ABUTMENT,
LOOKING WEST**

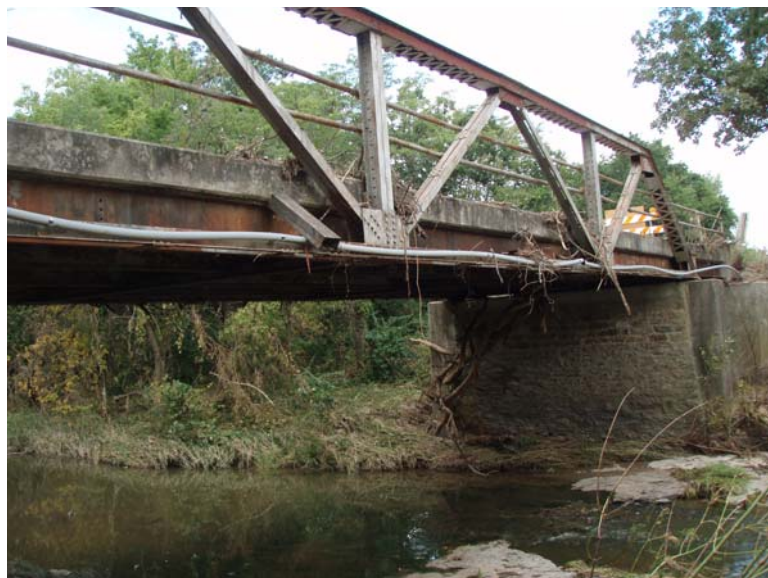
**SIDE VIEW LOOKING NORTHWEST, NOTE
ELECTRICAL CABLE ON BRIDGE,
POSSIBLE ELECTRICAL SHORT**
