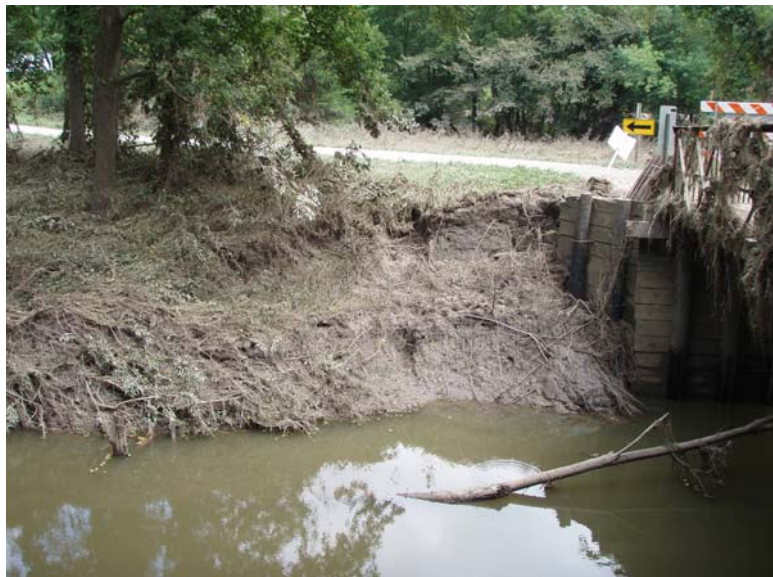
**EROSION AT NORTHEAST CORNER,
LOOKING SOUTHEAST**

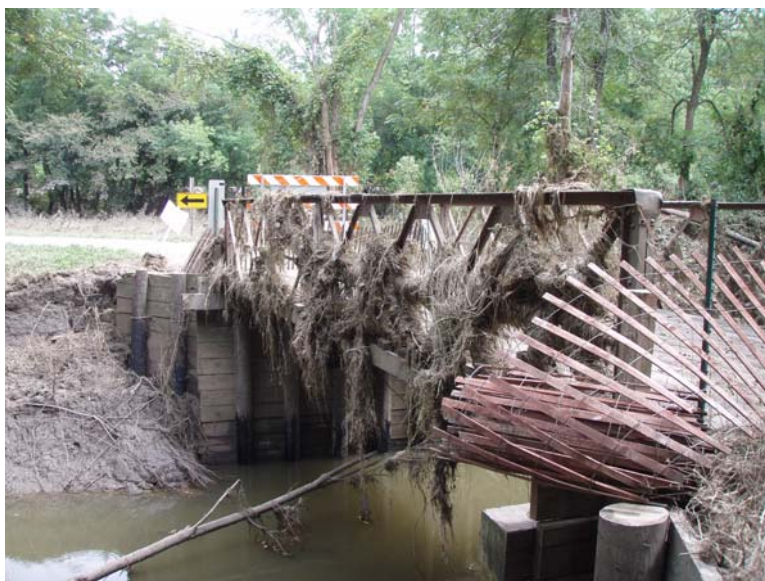
**DRIFT IN TRUSS,
LOOKING SOUTHEAST**

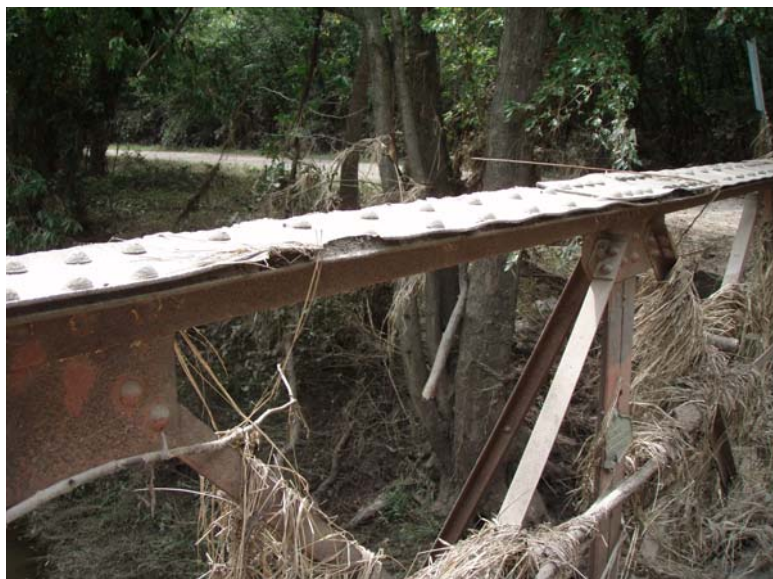
**CORRODED AND RIPPLED SOUTH TRUSS,
TOP CHORD**
