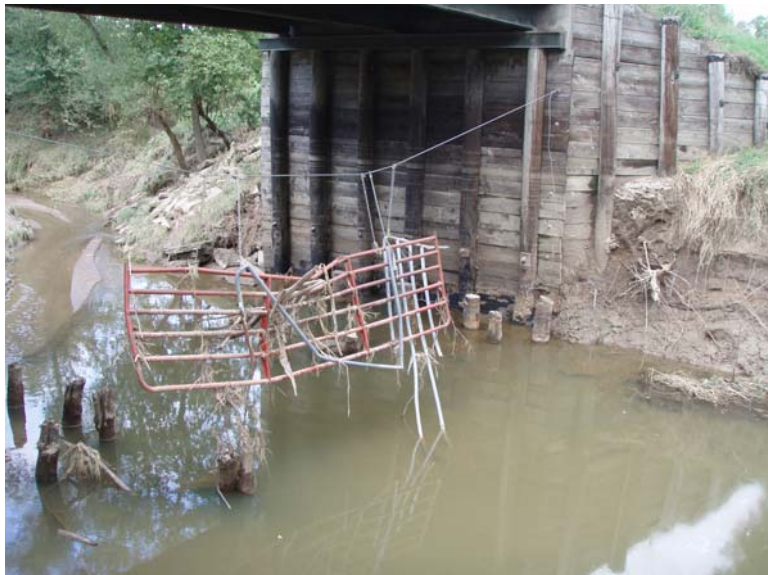
**EROSION AT EAST BACKWALL,
LOOKING EAST**

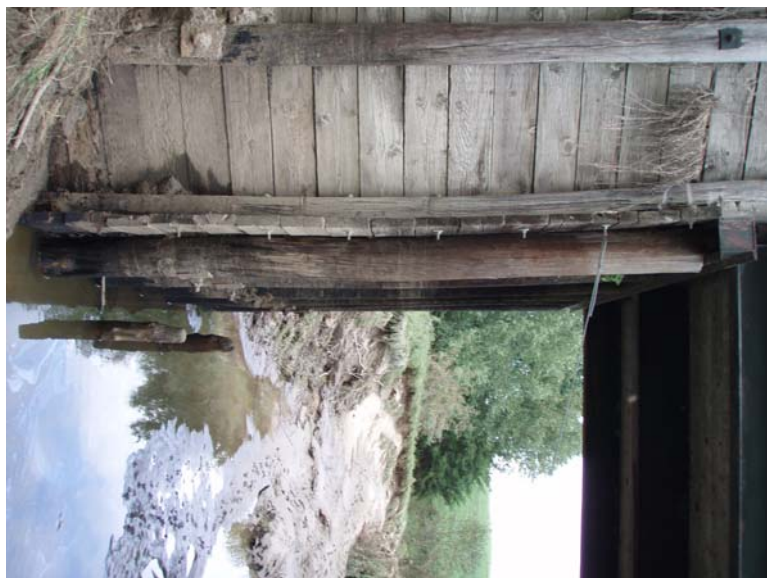
**FLEXING WEST ABUTMENT PILE,
LOOKING NORTH**
